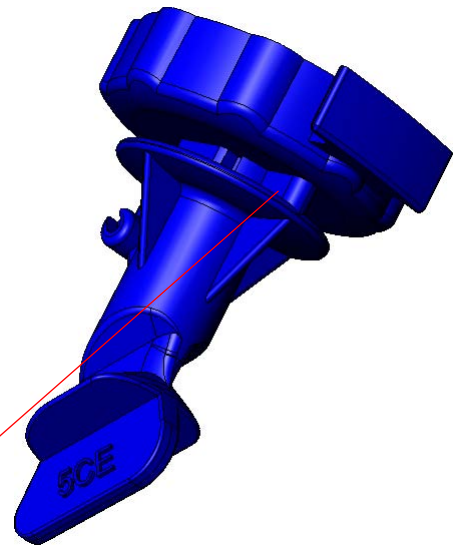
Fig. 2 - 5CE

Rib added on the back of the tip to hold the tip in place.

Rib have 0.21" of conact with groove on stand when installed

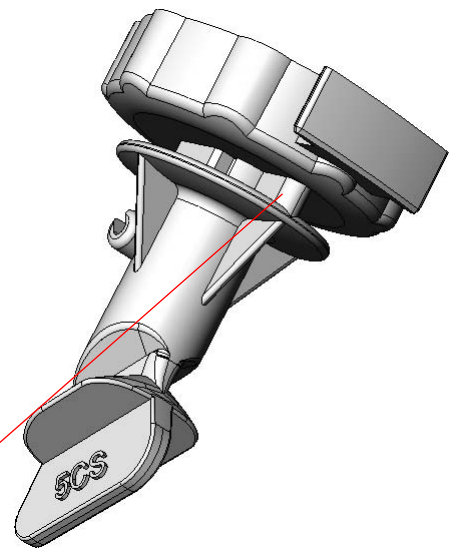
Fig. 5 - 5CS

Rib added on the back of the tip to hold the tip in place.

Rib have 0.21" of contact with groove on stand when installed
